PRIMARY RECORD

Page 1 of 2 *Resource name(s) or number (assigned by recorder) 1210 17TH ST

P1. Other Identifier Pacific Rolling Mills (historic)

Page 1 of 2 *Resource name(s) or number (assigned by recorder) 1200 17TH ST

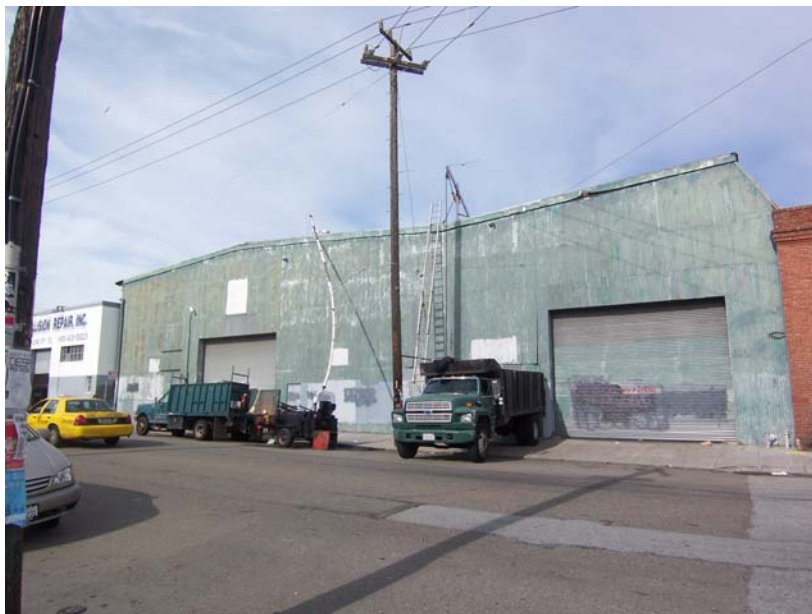
*P5b. Photo (view, date, accession #
100_1867.JPG, 11/16/2007,
View toward northwest,

1210 17th Street is a one-story, wood-frame industrial building clad in corrugated steel and capped by a compound gable roof. It is connected to the building on the adjoining parcel 3949002. The utilitarian building occupies a 56,000 sq ft lot that extends through to 16th Street. The south façade faces 17th Street and features two large loading bays with metal roll-up doors. The north façade facing 16th Street features two large loading bays with metal roll-up doors and a metal pedestrian entrance accessed by metal steps. The building terminates with a plain metal coping. The minimally altered building appears to be in fair condition.

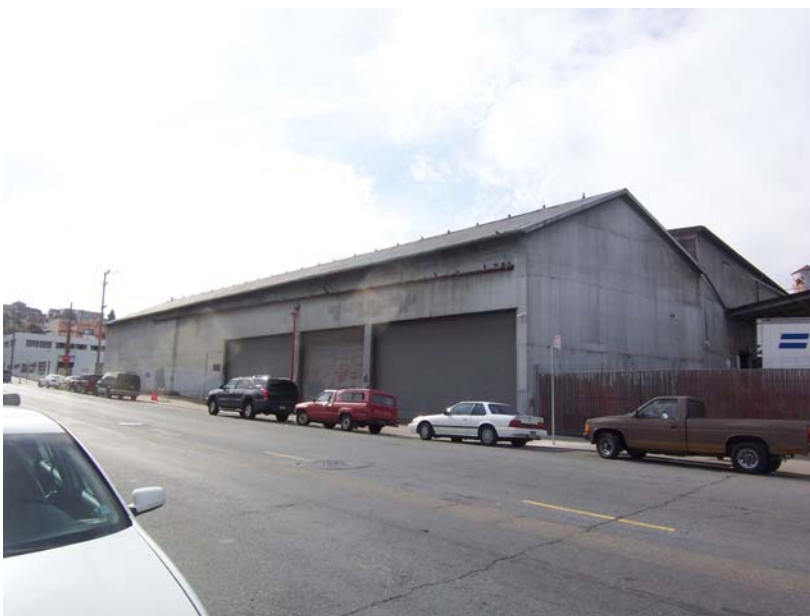
View toward southwest,
11.16.07, 100_1862.JPG

This parcel contains two buildings, each recorded separately. This record is for 1200 17th Street, a two-story, wood-frame industrial building clad in corrugated metal siding and capped with a gable roof. This building is connected to the two buildings on the adjoining parcel 3950001. The utilitarian building is located on the northwest corner of 17th and Mississippi Streets on a 48,000 sq ft lot. The south façade faces 17th Street and features several steel sash industrial windows running the majority of the length of the second story. A flush metal pedestrian entrance on the left side and a large loading bay on the right side characterize the first story. The east façade faces Mississippi Street and features three large loading bays on the right side. The building terminates with overhanging eaves and metal coping. The minimally altered building appears to be in good condition.
