PRIMARY RECORD

Page 1 of 2 *Resource name(s) or number (assigned by recorder) 1210 17TH ST

P1. Other Identifier Pacific Rolling Mills (historic)

Page 1 of 2 *Resource name(s) or number (assigned by recorder) 1200 17TH ST

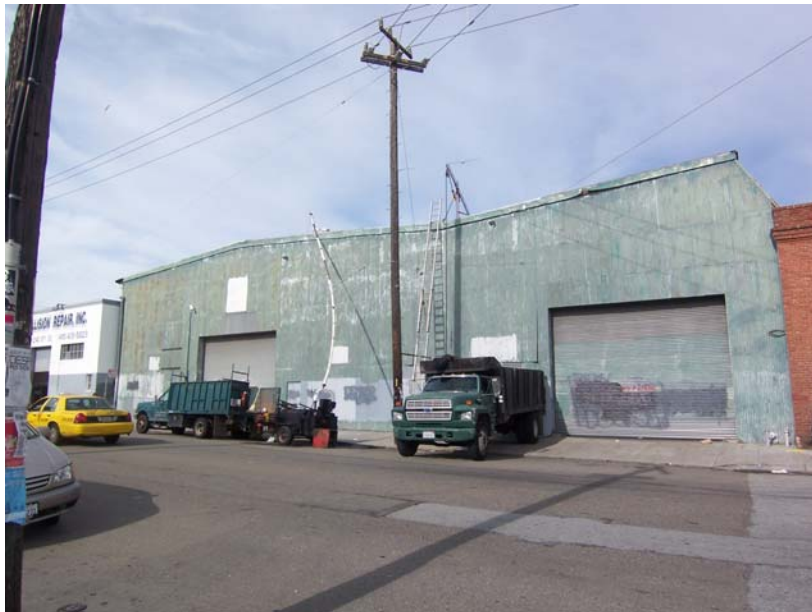
*P5b. Photo (view, date, accession #
100_1867.JPG, 11/16/2007,
View toward northwest,

1210 17th Street is a one-story, wood-frame industrial building clad in corrugated steel and capped by a compound gable roof. It is connected to the building on the adjoining parcel 3949002. The utilitarian building occupies a 56,000 sq ft lot that extends through to 16th Street. The south façade faces 17th Street and features two large loading bays with metal roll-up doors. The north façade facing 16th Street features two large loading bays with metal roll-up doors and a metal pedestrian entrance accessed by metal steps. The building terminates with a plain metal coping. The minimally altered building appears to be in fair condition.
